# Lairdmannoch Energy Park

## Technical Appendix 8-1: Peat Landslide Hazard and Risk Assessment

Lairdmannoch Energy Park Limited

May 2025

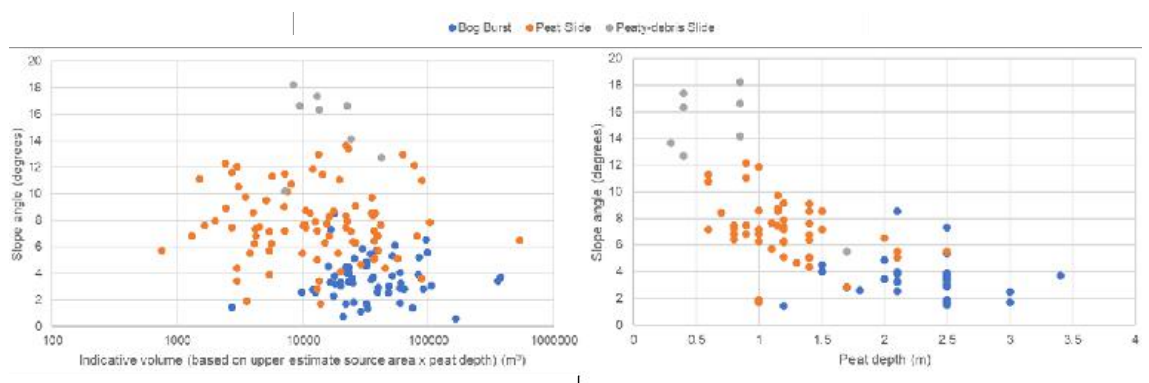
**Plate 4 Reported slope angles and peat depths associated with peat slides and bog bursts (from literature review of locations, depths and slope angles, after Mills, 2002)**

The term “peat slide” is used to refer to large-scale (typically less than 10,000 of cubic metres) landslides in which failure initiates as large rafts of material which subsequently break down into smaller blocks and slurry. Peat slides occur ‘top-down’ from the point of initiation on a slope in thinner peats (between 0.5m and 1.5m) and on moderate slope angles (typically 5°-15°, see Plate 4).

Due to the combination of moderate slopes and thinner peat on the Proposed Development Site, the most likely mode of failure is peat slides, and this is the failure mechanism considered in this report. This is in keeping with the most likely mode of failure for the peat depths and slope angles present at the Proposed Development Site (see **Plate 4** and **Figures 8-1-1** and **8-1-4**).

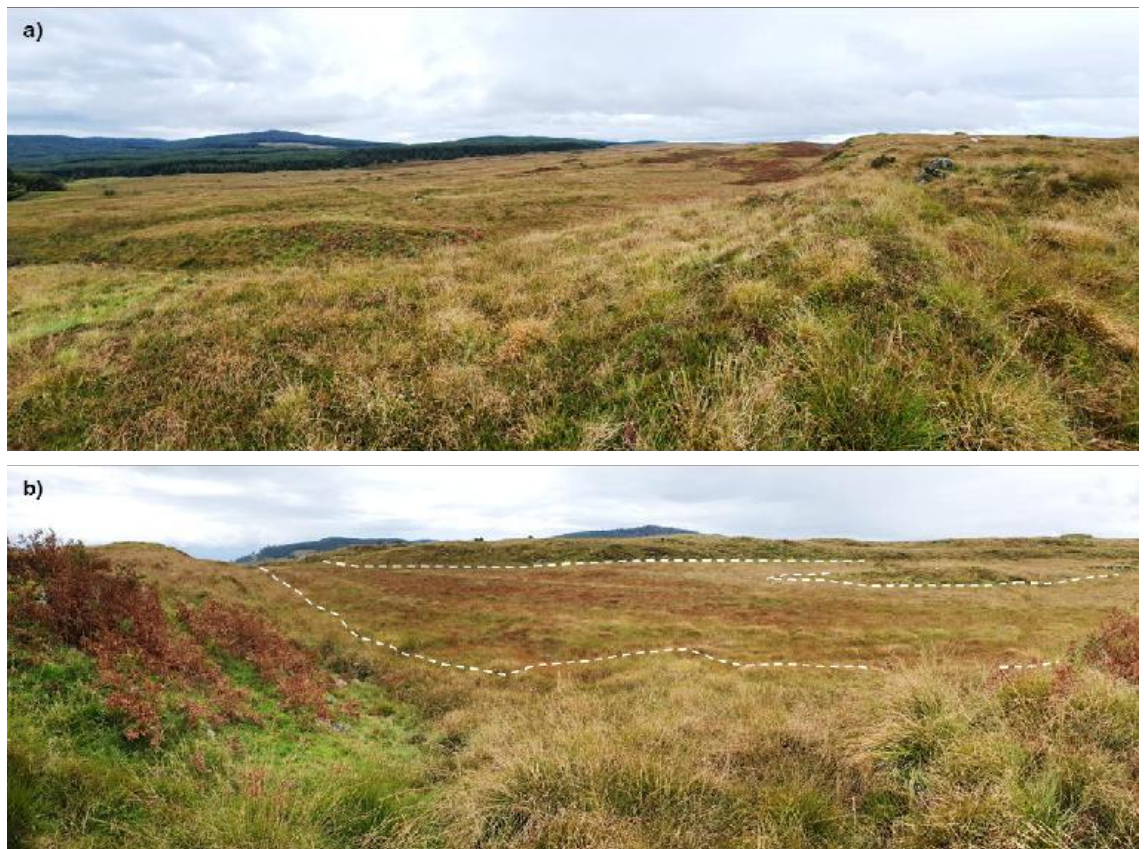
**Plate 6 Typical ground conditions in the northwest of the Proposed Development Site: a) bedrock escarpment above undulating terrain b) peat filled trough between bedrock ridges (limits of peat deposit shown with hashed lines)**

The resulting geomorphological map (**Figure 8-1-6**) was subsequently verified during a site walkover undertaken in September 2020 by a Chartered Geologist / peatland geomorphologist with over 20 years' experience of assessing peat landslides. Plates 6 and 7 show typical features identified during the walkovers.
